PROJECT NO: 2482-A  
PROJECT NAME: Shellman House Repairs

**A-202**

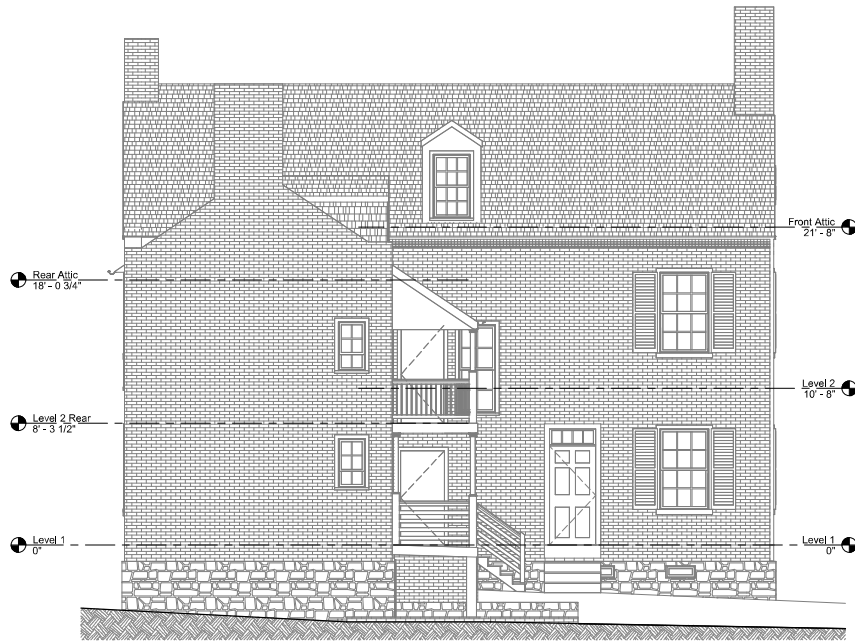
**1 North**  
1/4" = 1'-0"

- 1 REMOVE DAMAGED BRICK & REPLACE w/ SALVAGED ANTIQUE BRICK
- 2 REPOINT STONE MORTAR JOINTS
